Operation of the BigRIPS cryogenic plant

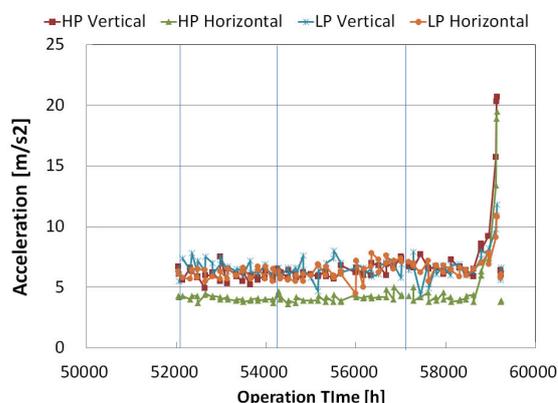
The third incident was an unusual noise that was produced by the main motor of the compressor unit. We first noticed the noise in mid-November and the noise level gradually increased daily, even though we had greased the motor unit. Since 2015, we have regularly measured the vibrations of the main compressor unit using an OH-580A hand-held vibration tester.⁴⁾ The vibration acceleration in the vertical and horizontal directions as a function of the total operation time is shown in Fig. 1. Measurements were

performed both at the high-pressure and low-pressure sides of the compressor. It is clear that the vibration acceleration increased drastically after hour 58,630 of operation, which corresponds to Nov. 14. On Dec. 5, the acceleration exceeded more than 20 m/s² and the noise level became dangerously large, so we decided to cancel the beam time and stop the compressor unit on Dec. 6. After a 6-h recovery operation after the expansion turbines were stopped, the compressor was safely stopped. Using a temporary recovery line, evaporated helium gas from the STQ cryostats was successfully transferred to the RIKEN liquid-helium supply and recovery system.

Fig. 1. Vibration acceleration of the compressor unit.

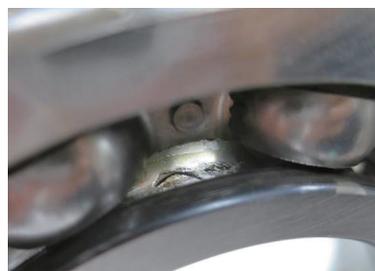
The main motor unit was disassembled on site to investigate the origin of the unusual vibrations. In a bearing unit on the anti-coupling side, damage was found on a surface of its inner ring (Fig. 2). The motor unit was reassembled with a new bearing unit. After careful mechanical and electrical checks of the whole compressor unit, the test operation was successfully performed and the vibration acceleration was measured to be less than 8 m/s². The origin of the bearing damage is under investigation.

Fig. 2. Damaged bearing unit, disassembled from the anti-coupling side of the motor unit.
