Operation of the BigRIPS cryogenic plant

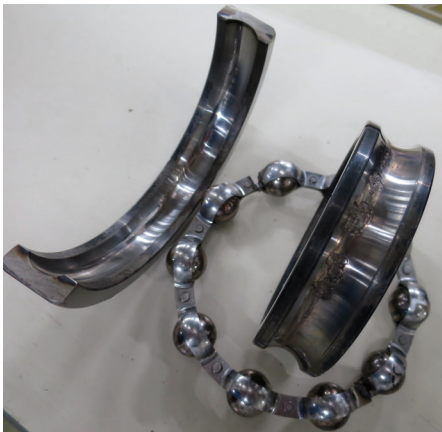
The main motor unit was disassembled on site to investigate the origin of the unusual vibrations. In a bearing unit on the coupling side, damage was found on a surface of its inner ring and the bearing balls (Fig. 1). We also found that the size of the housing for the damaged bearing unit was 5 μm larger than its dimension standard (+0–25 μm). The motor unit was reassembled with new bearing units, and the housing was re-manufactured with a tolerance of +0.0 μm . After the regular maintenance of the whole compressor unit, a test operation was successfully performed, and no unusual noise was produced in the second operation period.

Fig. 1. Damaged bearing unit, disassembled from the coupling side of the motor unit.

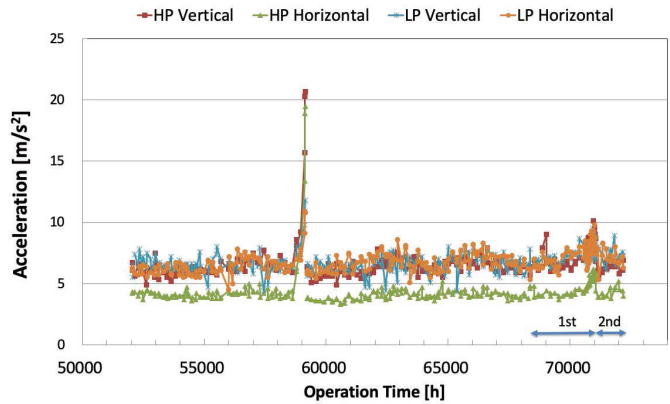
Figure 2 shows the vibration acceleration in the vertical and horizontal directions as a function of the total operation time. Two rapid increases of the vibration acceleration at operation times of 59,000 h and 71,000 h indicate the damage of the bearing unit occurred in Dec. 2016¹⁾ and in June 2019. The vibration acceleration re-

Fig. 2. Vibration acceleration of the compressor unit. Two operation periods are indicated by arrows.

mained less than 8 m/s^2 in the second operation period.
